QA-409

INVENTORY FORM FOR STATE HISTORIC SITES SURVEY

"Bourbon", "Dr. James Bordley Farm"

Rabbit Hill Road, 1.2 miles northeast of Price

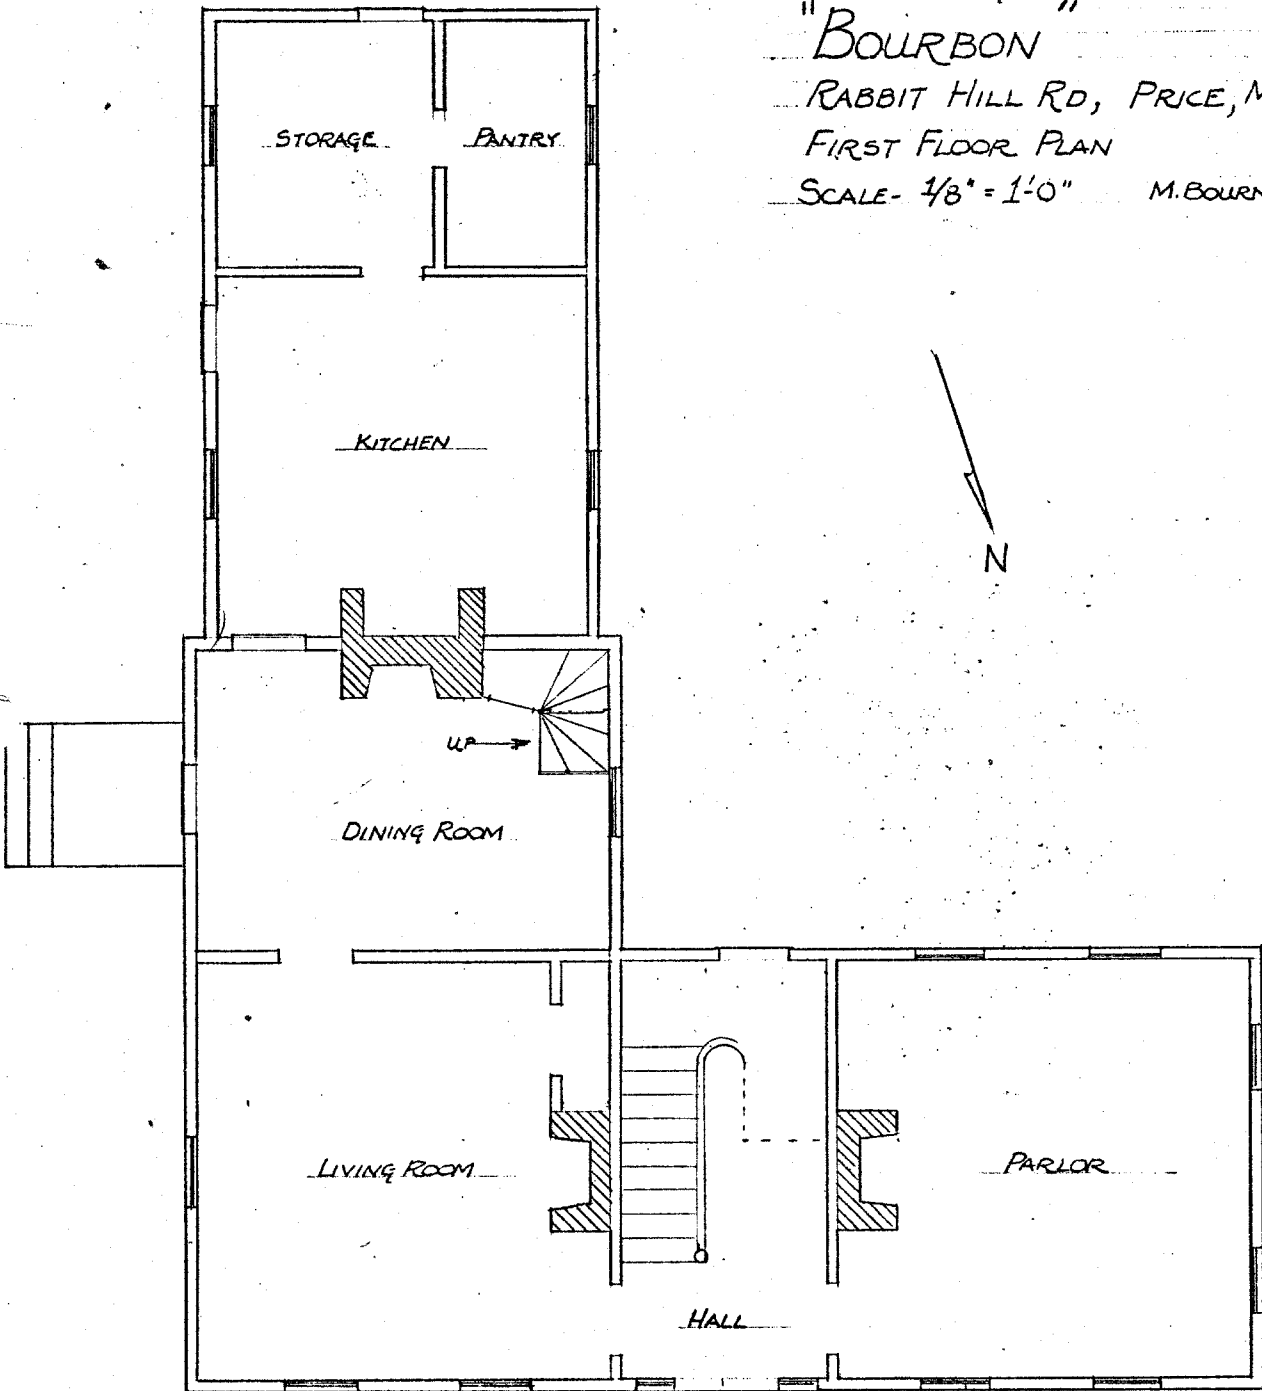
FIRST FLOOR PLAN

Inside, the plan of the house is a variation of the mid-19th century ante-bellum plan. Two parlors and central stair passage with a room (Dining Room) behind the east parlor are in the 'L' plan hip roof part. The service wing has a kitchen adjacent and one step down from the dining room. Beyond the kitchen is a storage room and pantry.

The unusual feature of this house is the position of the back stair, a winder in the southwest corner of the dining room. Unlike the usual winder, the bottom step is perpendicular to the wall, thus ascending 90° to the door at the lower end of the stair. Also unusual is the fact that the closet beneath the stair is on a diagonal and the area above the door is filled by two panels with bead around the panels. It appears to be the only vernacular or "built on the job" part of

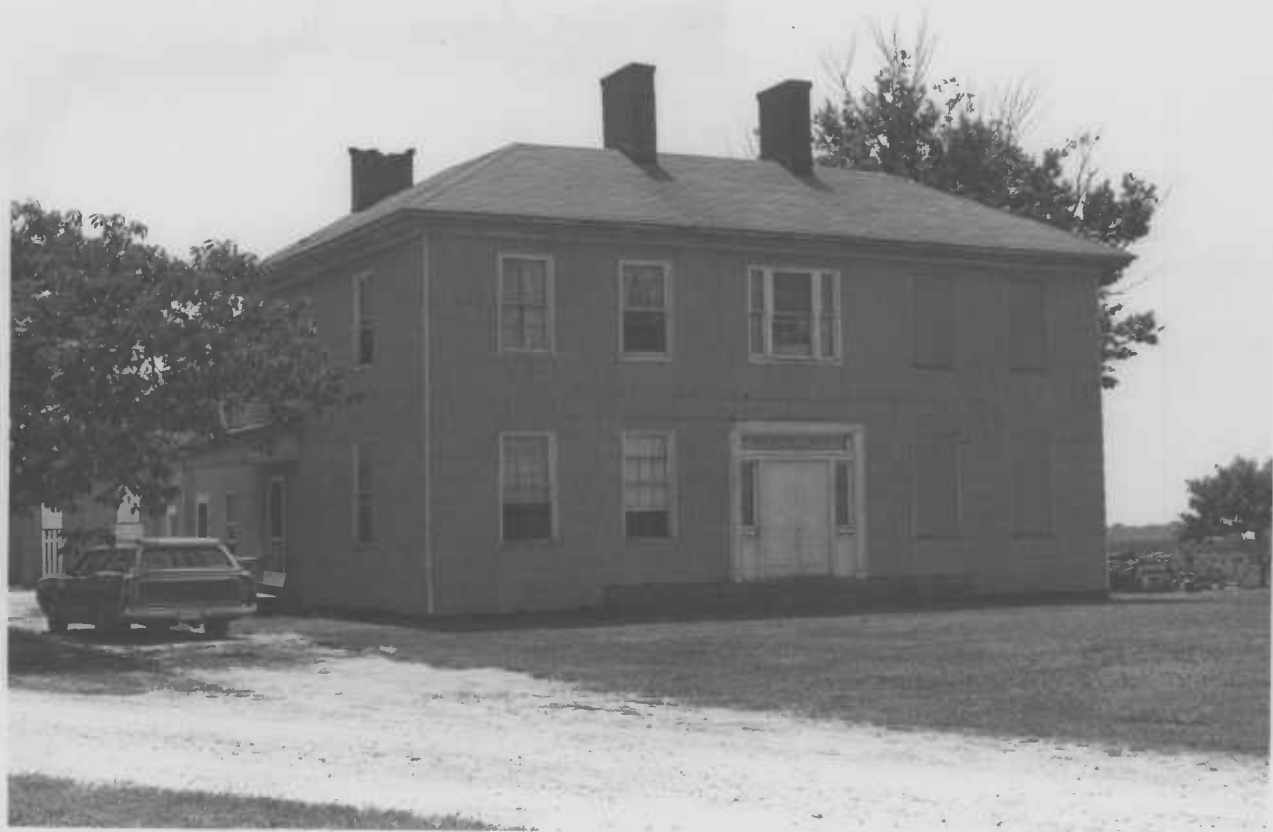
"Bourbon"
Northeast

The house is located on the south side of the road and faces north. It is a five bay wide 'L' plan, two-story hip roof frame structure standing on a low brick foundation. The walls are covered with composition siding. The central entrance of the north facade is a typical mid-19th century unit, with sidelights, transom and double doors. There was originally a porch across three of the five bays, but it was removed within the last 30 years. There is a wide overhanging cornice to the roof. Two large chimneys rise from the center of the roof and one in the back of the 'L'.

Beyond the 'L' is a two story, three bay frame service wing slightly narrower and lower than the main body of the house. The east side of the whole house consists of the following, from north to south: a large window, an entry with leanto porch, and two smaller windows with a door between. The second story

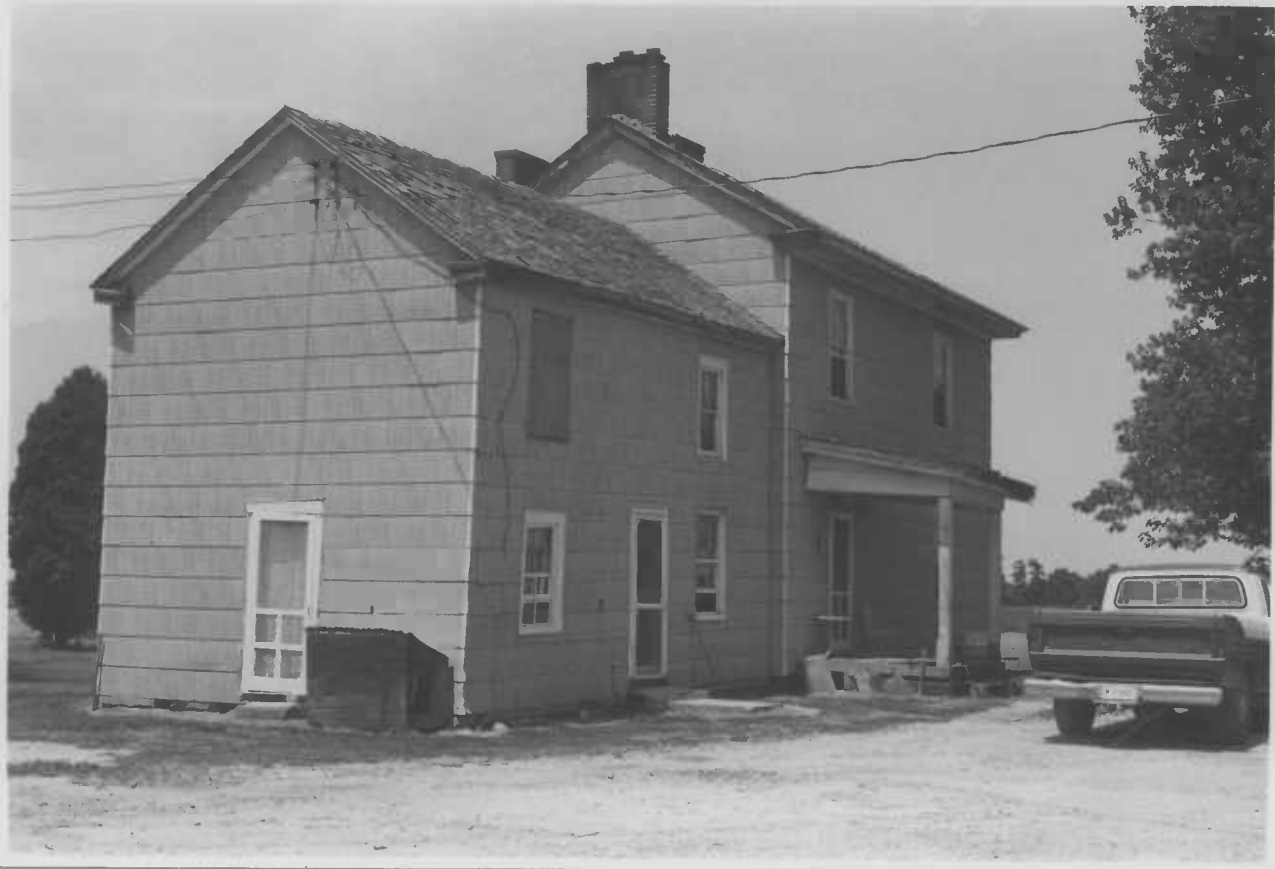
South

The south gable of the service wing has only one door centered on the first story. The west side of the service wing has two windows on each story. Like the east side, the back of the 'L' is slightly deeper than the service wing. It has only one window on each floor.

There are two windows and a door on the south facade of the front part of the house and two windows on its west side.
